Aviation Investigation Final Report

Location:	Harrison, Michigan	Accident Number:	CEN22FA029
Date & Time:	November 5, 2021, 09:37 Local	Registration:	N16TG
Aircraft:	Vans RV	Aircraft Damage:	Destroyed
Defining Event:	Loss of control in flight	Injuries:	1 Fatal
Flight Conducted Under:	Part 91: General aviation - Personal

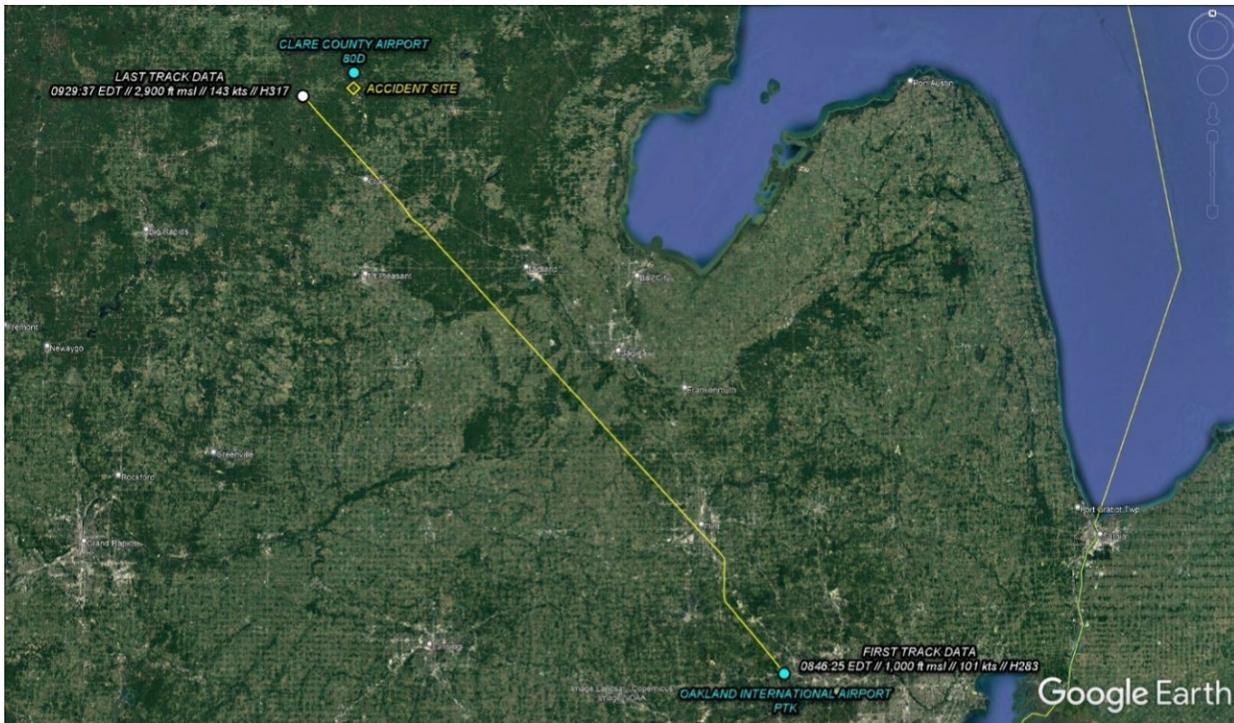
Figure 1. Plot of ADS-B track data for the entire flight.

ADS-B data indicated that the airplane departed runway 27L at Oakland International Airport (PTK), Pontiac, Michigan at 0846. After departure the airplane made a climbing right turn and flew northwest for about 12 nm, then turned north for about 5 nm, then back to a northwest heading. The airplane reached a cruise altitude of about 3,000 ft mean sea level and remained on the northwest heading until track data was lost about 0905. The last ADS-B position was about 56 nm and 143° from the accident site. Discrete radar beacon returns showed that the airplane continued a straight-line course for another 60 nm after the loss of ADS-B data. The radar data showed that the airplane was in straight and level flight before the end of the data. The accident site was located about 1 nm south of the approach end of runway 36 at the Clare County Airport (80D), Harrison, Michigan.

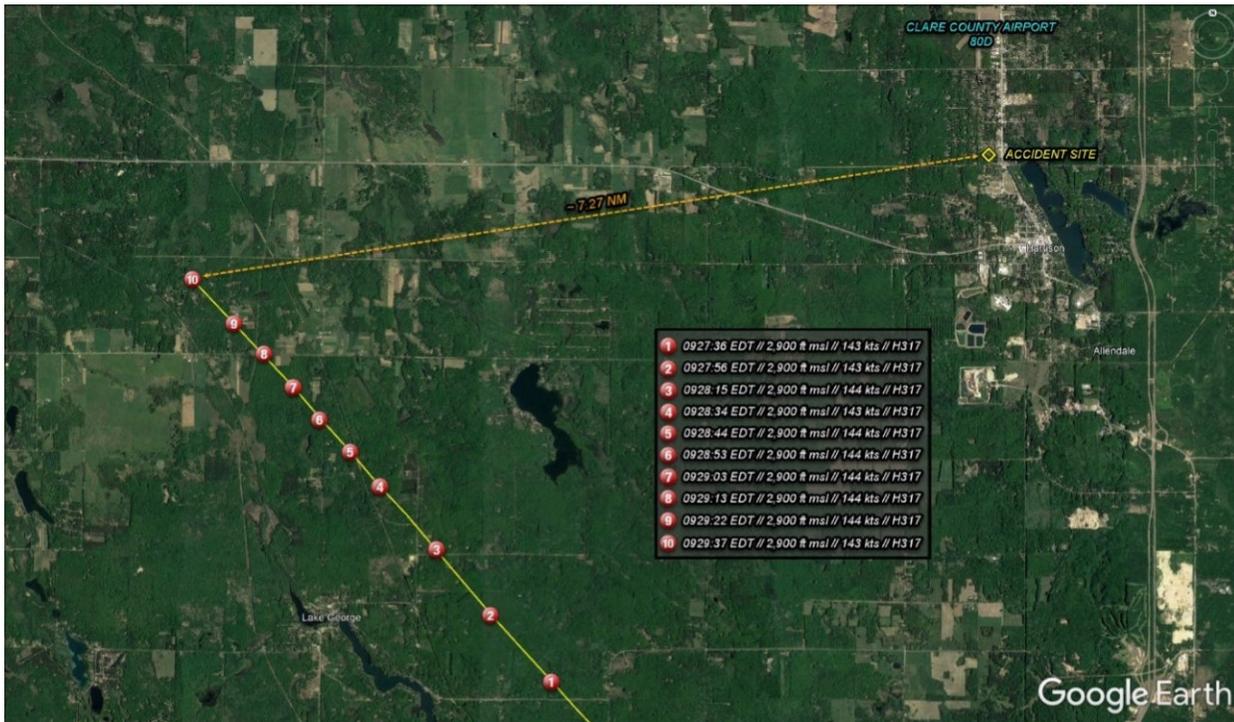
Figure 2. Plot of the final portion of the accident flight.

The accident site was located about 7.3 nautical miles (nm) to the east of the last recorded track and about 1 nm south of the approach end of an airport runway. The location of the accident site suggests that the pilot had diverted from his original course and was attempting to land at the nearby airport. The loss of automatic dependent surveillance-broadcast (ADS-B) flight track data and discrete radar beacon returns indicated an interruption of transmission of the data from the airplane.

No manufacturer published glide ratio data were found for the accident model airplane; however, builder data from online sources indicated that a glide ratio of about 7:1 was achievable. The distance and altitude from the last radar return to the accident site would have required a glide ratio of about 23:1.

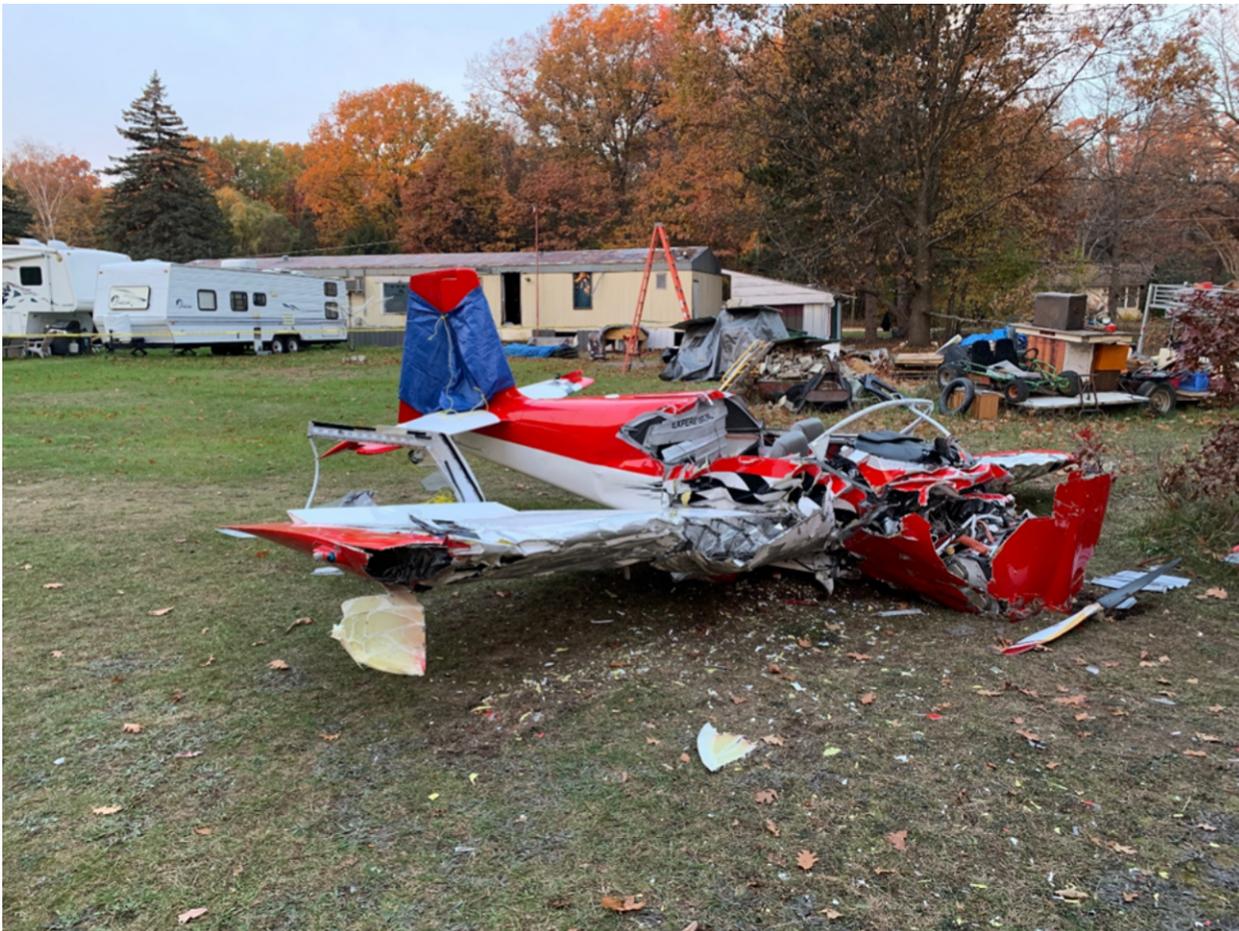
Figure 3. Airplane at accident scene.

The airplane impacted the back yard of a residence. Impact signatures indicated that the airplane struck the ground about 45° nose low. The initial impact point was located directly

beneath the airplane. The airplane remained predominately intact with all major airframe components still connected. The engine was partially attached to the fuselage. The three-blade wood core propeller was attached to the engine. One blade was broken off near the blade root. None of the propeller blades were splintered and they were predominately intact, consistent with low or no engine power at impact.
